2. Site analysis

2.1 Park Assessment

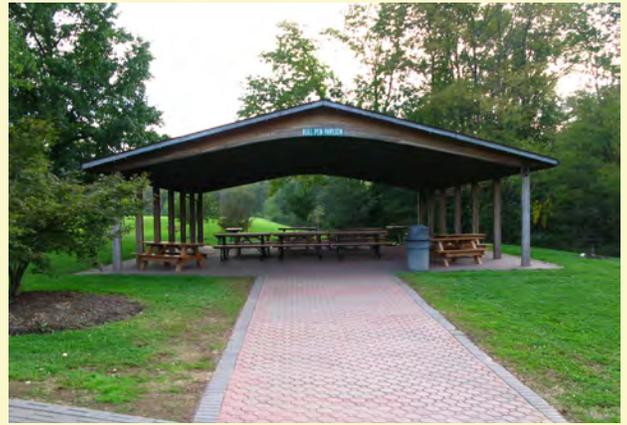
Bull Pen Pavilion – This is a relatively new Cedar Forest pavilion that is in excellent condition. It is 55 by 40 feet with a unit paver base and is outfitted with electric supply and approximately 14 unfixed picnic benches. The tables are new and in good condition.

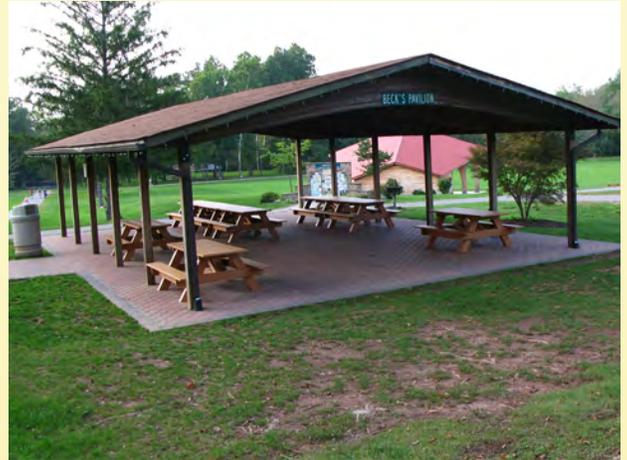
Beck's Pavilion– Beck's is also a new Cedar Forest pavilion that is in excellent condition. It is slightly smaller, roughly 45 by 32 feet, with unit paver base and is outfitted with electric supply and eight picnic benches.

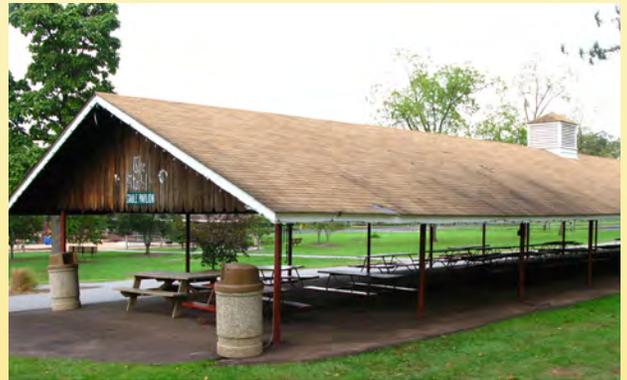
Stable Pavilion – The Stable Pavilion is one of the older pavilions in the park. It is located between the park path and the 5 – 12 year old playground. The pavilion is 105 by 30 feet and has an asphalt floor that is cracked and uneven. The roof is missing some shingles and hangs low, especially at its eaves, presenting a hazard to people who might hit their head. There are approximately 18 unfixed picnic tables that are older and should be replaced. The pavilion has an attached storage area that is roughly 20 by 30 feet.

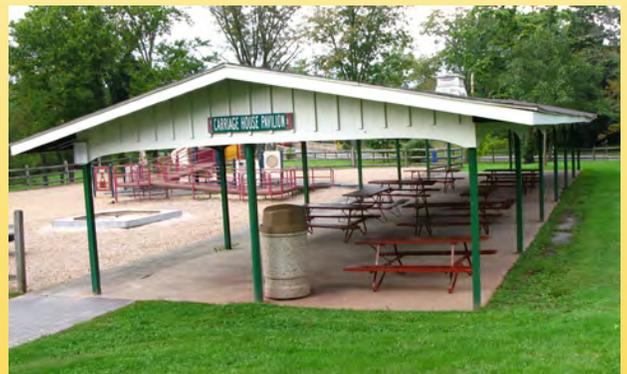
Carriage House Pavilion – This pavilion is located adjacent to 5-12 year-old playground. It is 22 by 80 feet and is in fair condition. The roof is older and the poured concrete floor is cracked. It is anticipated that this pavilion will be demolished if the Bustard Road Bridge is replaced and the road is realigned. The pavilion has roughly 10 unfixed picnic tables that are older but are in fair condition.

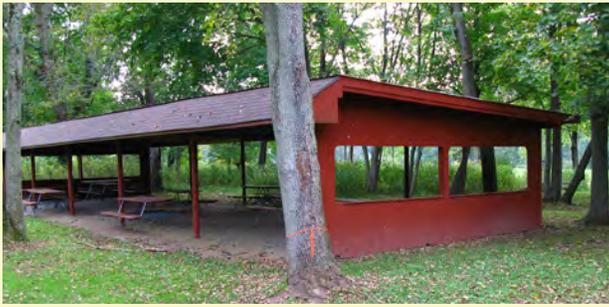
Boathouse Pavilion – The Boathouse Pavilion is located near Towamencin Creek in the 100-year floodplain. The roof contains holes and is in poor condition. The concrete floor is cracked and uneven. The picnic tables are old. This pavilion is note well used, is in poor condition, and should be demolished.

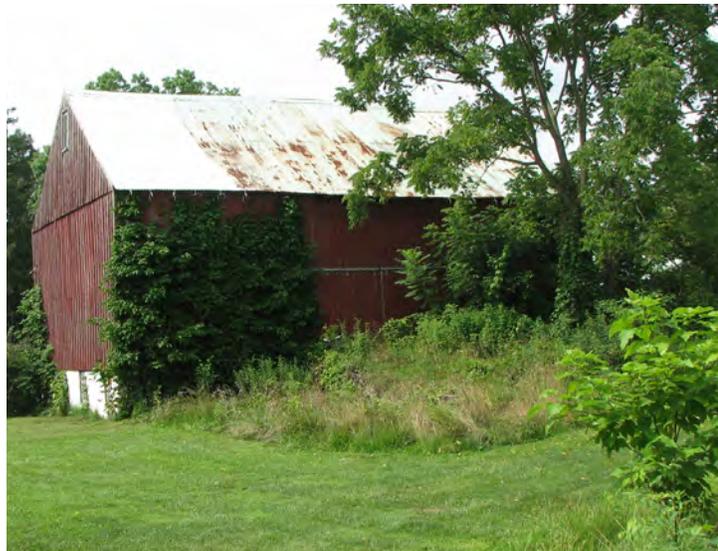
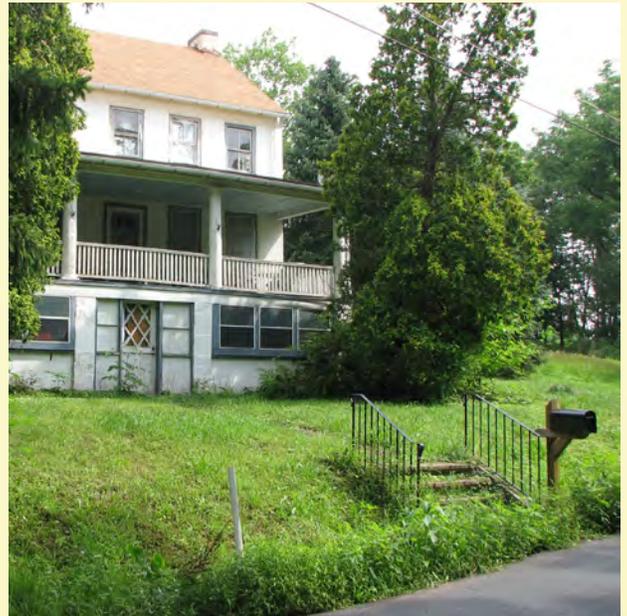
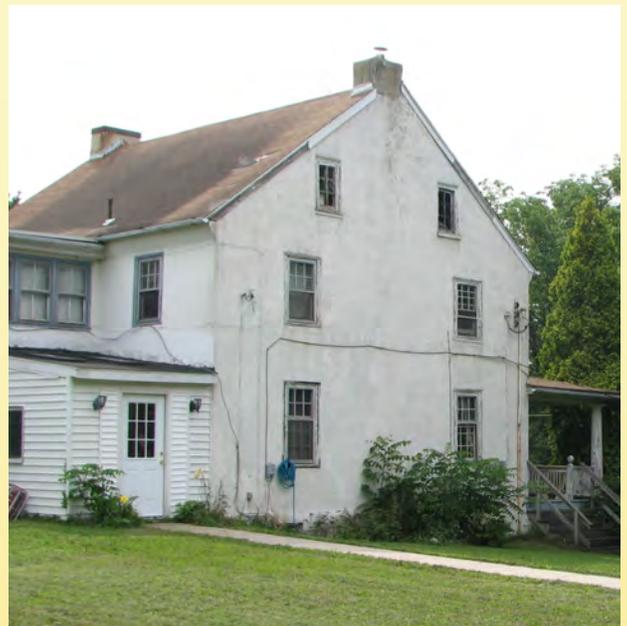
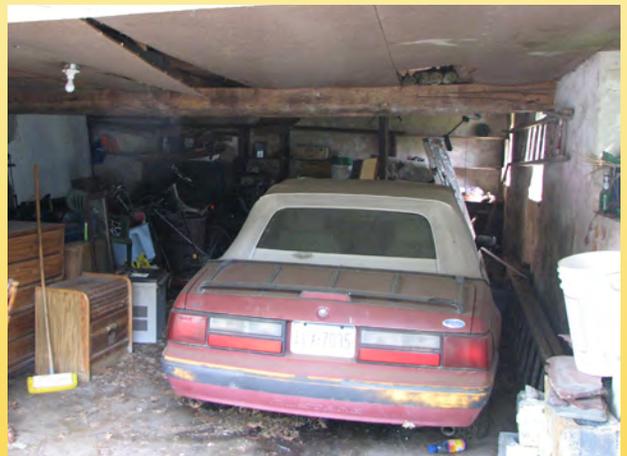
Ruth House – The Ruth or Hanks house is located on the northeast side of Kriebel Road. The property has a “lifetime lease” and will continue to be lived in during the lifetime of Mrs. Arneth or when the current occupant moves out. The Township maintains the exterior of the building, but the current occupant is responsible for repairs to the interior that are up to \$1,000. The Township is concerned about the interior conditions based on visual inspection of the house.

Upper Barn – The use of the upper barn runs with the lifetime lease of the Ruth House. The ground floor is open and currently used for storage and parking. The building is in very poor condition. It is overgrown and there are structural concerns. Estimates for repairing the structure were in excess of \$300,000 as reported in the 1998 Master Plan. Since this time no improvements have been made and the costs of restoration have surely gone up. There is also a safety concern as with any deteriorated building. Without a viable reuse, particularly one that would offset restoration costs, it is recommended that the building be demolished.

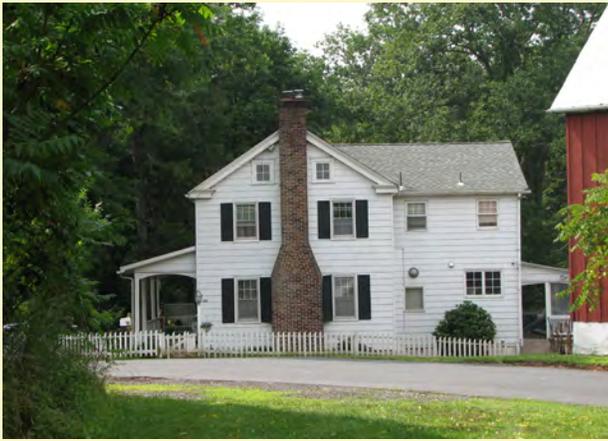
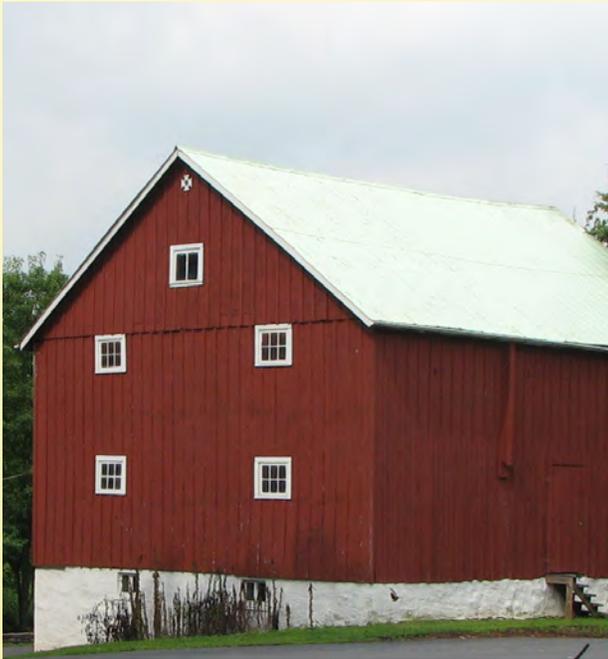
Arneth House – The Arneth house is located on the southwestern side of Kriebel Road. It is owned and maintained by Towamencin Township and is in fair condition. The Township rents it for residential use.

Lower Barn – The Lower Barn is adjacent to the Arneth House. It is in fair condition.

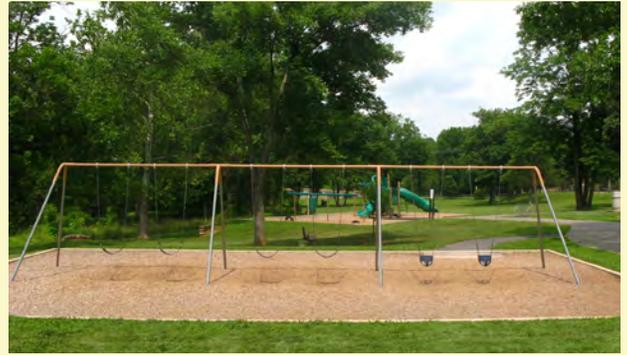
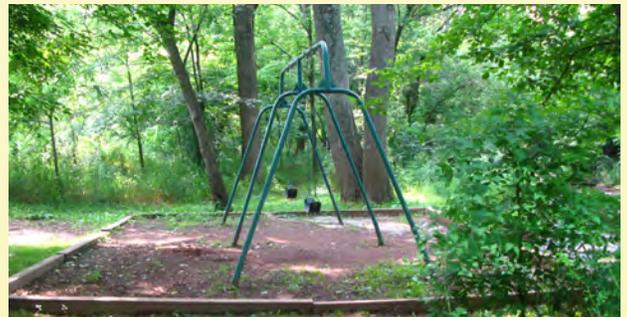
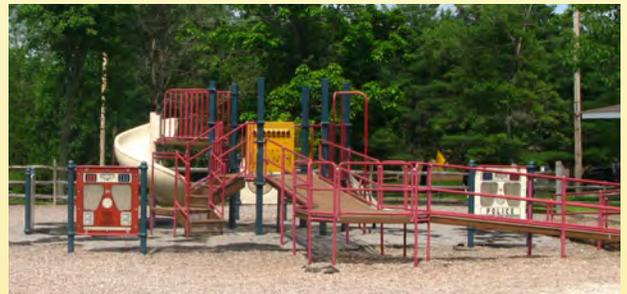
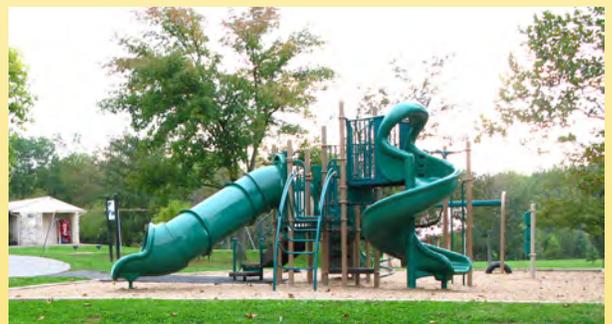
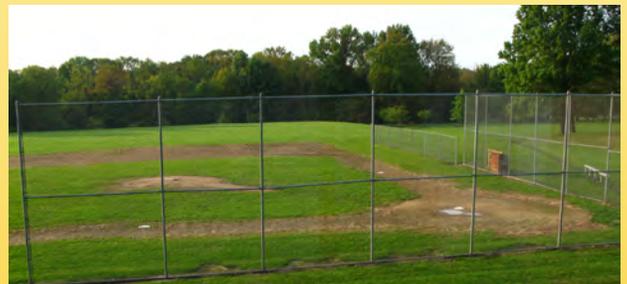
(2) Swing Sets – A swing set is adjacent to the tot lot on a wood chip surface. The set contains two baby swings and four swings with flexible rubberized seats. The swing set is in fair condition. It is accessed off of the trail system but is not ADA accessible.

The second swing set is in poor condition. It is located in an isolated wooded area along Towamencin Creek (northwest section of park) and should be removed. It is not ADA accessible.

Playground #1 (2 – 5 yrs) Tot lot – The tot lot is located adjacent to the Carriage Pavilion. It contains an older play structure with ramps, slides, and interactive play features. The surface is a combination of wood chips and a deteriorated soft surface. The Township should do minimal repairs to this structure and plan to replace it with a new more functional and accessible tot lot.

Playground #2 (5-12 yrs) – The 5 -12 lot contains a play manufactured structure with slides, crawling tubes, climbing ladders, and similar features. The structure is in fair condition overall. It is on a wood chip surface, which is not ADA compliant and is degraded and worn out. A rubberized entrance is provided from the park's path system to the structure, but it is in poor condition.

Baseball Field – The ball field is full sized and in fair condition. Its solar orientation, roughly southeast, is not considered appropriate for ball field because of sun glare. It is used informally by park users. No programmed or league games occur on the field.

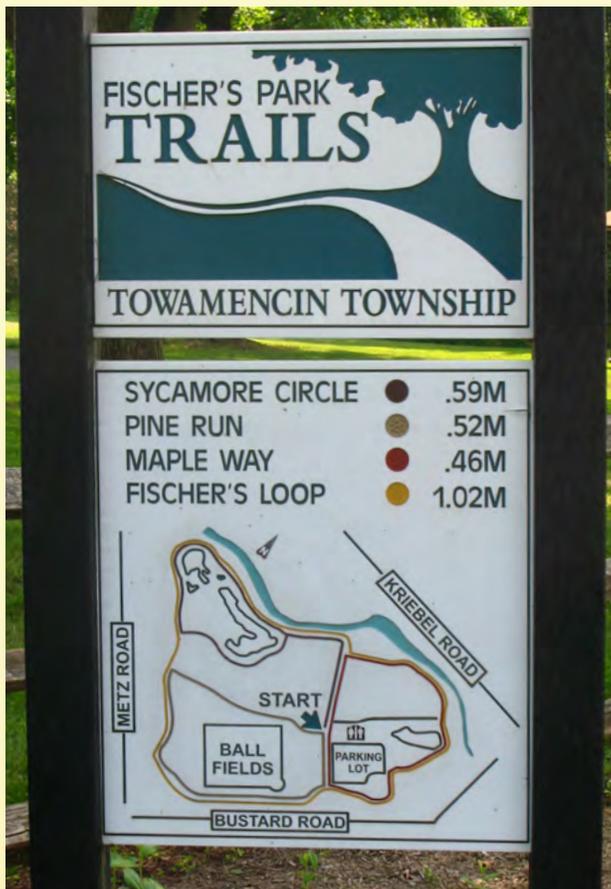
Four trail loops are identified in the park (shown in the picture to the left). The largest, Fischer's Loop, runs the perimeter of the park and is just over one mile. Maple Run, .46 miles, loops around the Arneth Center. Sycamore Circle, .59 miles, is in the western woodlands. Pine Run, .52 miles, is the park's southern section.

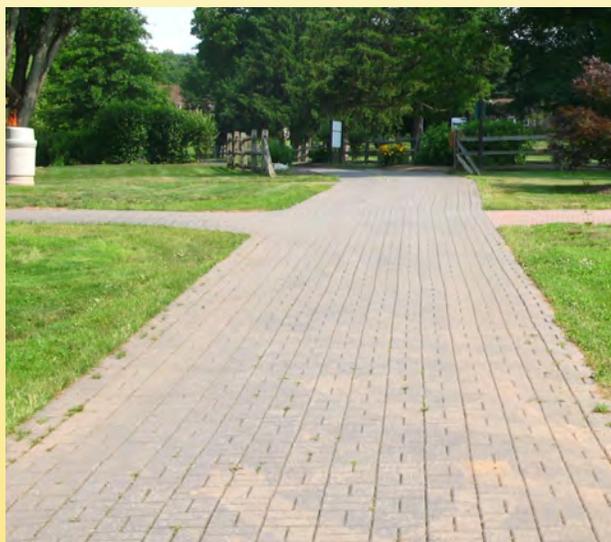
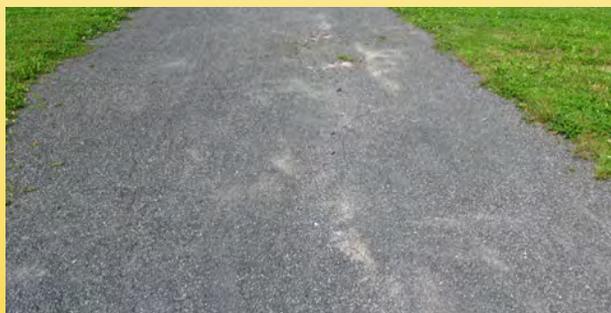
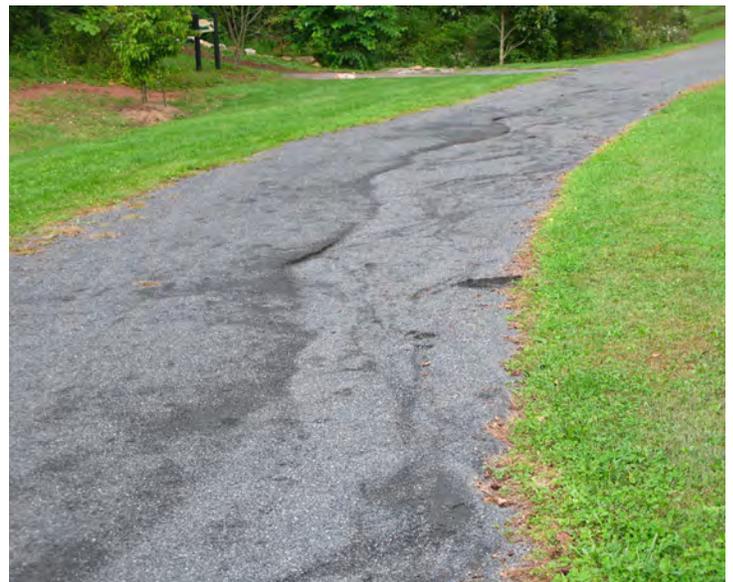
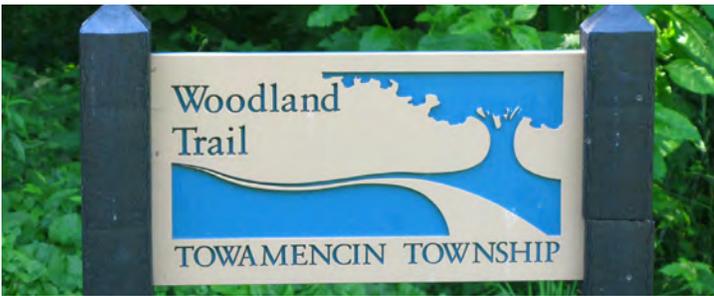
Unit Paver loop – There are roughly 3,000 linear feet of trail paved with unit pavers in the park. This surface is ADA compliant where slopes are not too steep. It is a very attractive surface and is generally in excellent condition. Continued maintenance is required to remove weeds and level or replace pavers that become loose.

Quarry Fines – Fisher's also has roughly 4,650 feet on stone dust trails. These trails pack as a hard surface and are ADA compliant where slopes are not too steep. Where the trail runs over steeper slopes stormwater washes away the upper layers of stone dust creating ruts. Stone dust must be added where this occurs. Alternatively, these short steep sections could be paved with asphalt to eliminate erosion.

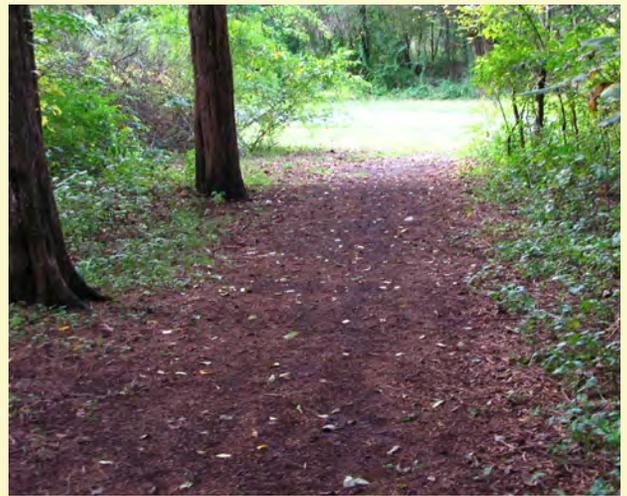
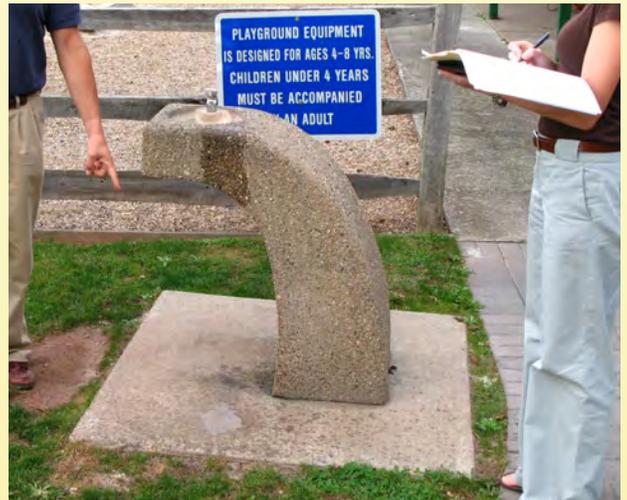
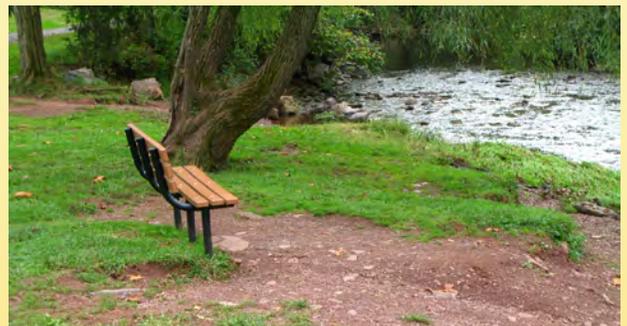
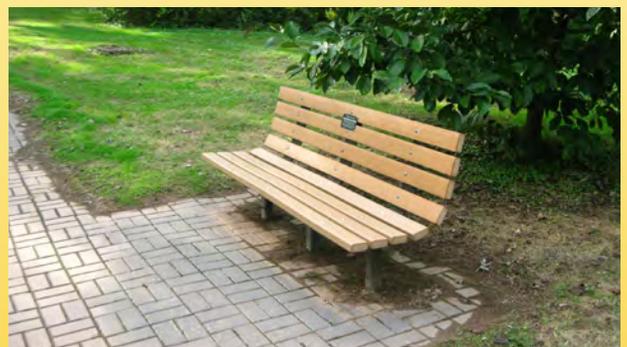
Drinking Fountains – Two water fountains are located in the park, and neither are ADA compliant. The fountain installed adjacent to the tot lot could be ADA compliant, but it was installed away from the trail instead of toward the trail as intended. The second fountain is located on the trail system between the Bustard Road entrance and the parking area.

Benches – Numerous benches are located throughout the park, mostly adjacent to the trails. Most benches are in good condition, but a number are installed on grass limiting ADA access.

Picnic Tables – There are approximately 65 picnic tables located under the park's pavilions. The tables in the Becks and Bull Pen Pavilions are in excellent condition. Tables in the other pavilions are older and a number should be replaced with new tables designed for ADA accessibility.

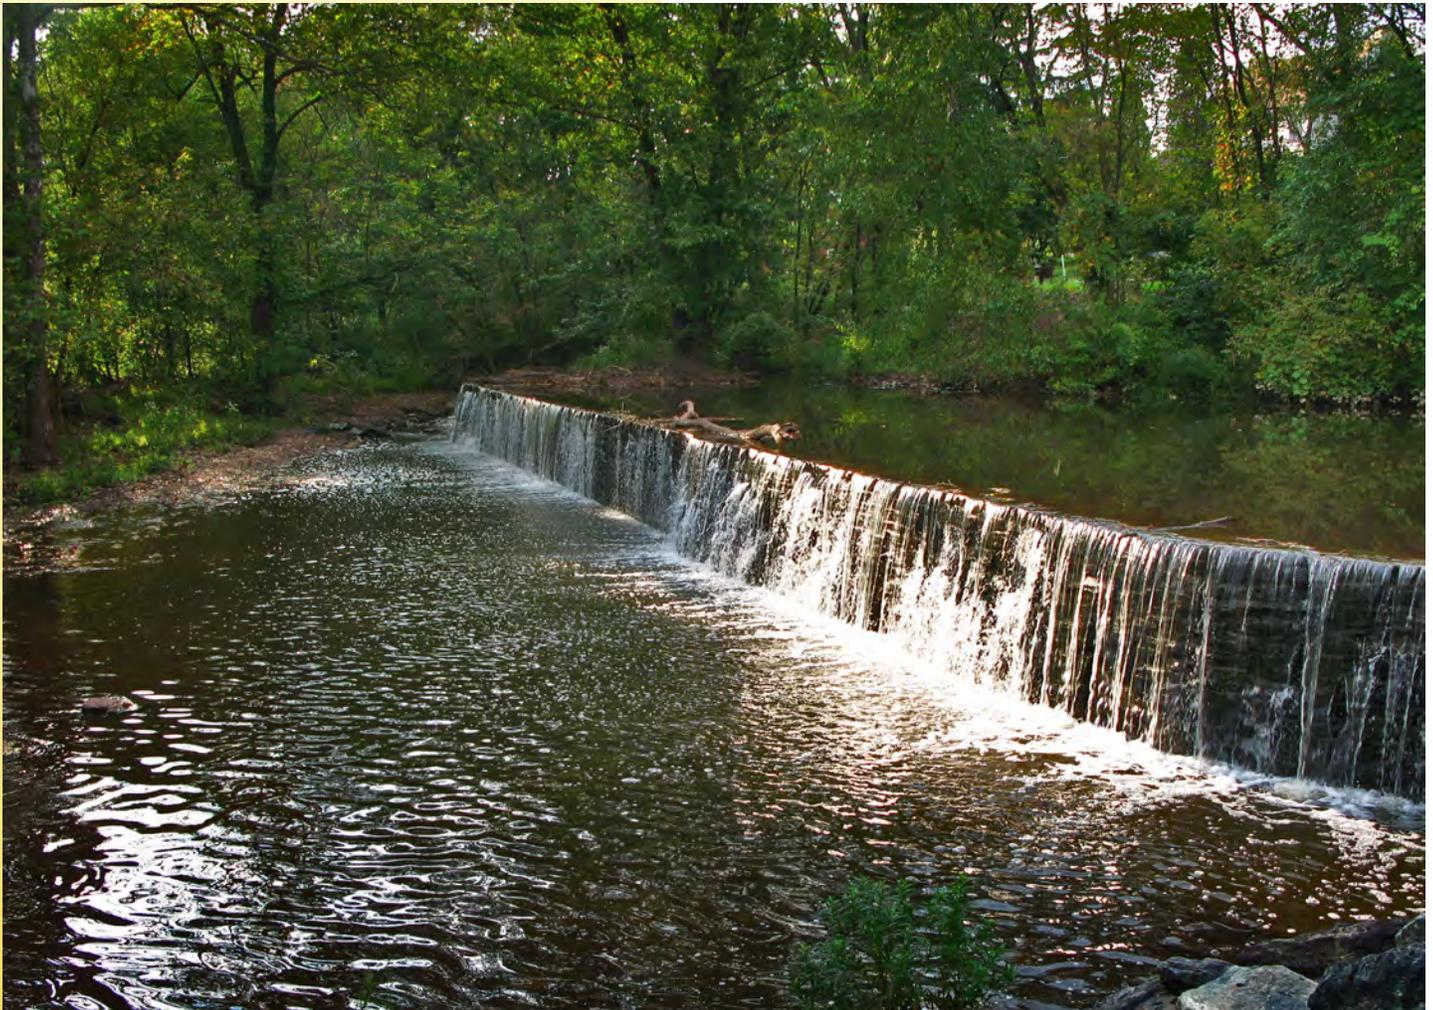
Originally part of the old mill race and mill, the dam has become a historic and aesthetic feature of the park. The dam creates a small pond area which provides an optimal fishing area and adds to the park aesthetic value. A small dam breach was observed by the Pennsylvania Department of Environmental Protection (PADEP) and recorded in their Dams and Waterways report during their inspection on June 24, 2008. As a result of this observation, an engineering inspection of the dam was conducted on September 25, 2008 by CMX. The report, which summarizes the dam inspection and repair recommendations, is located in the Appendix of this document. As stated in the report, the dam is observed to be in good condition with exception of the small dam breach at the right abutment. Two repair options were presented in the engineering report. Both included installation of rip rap and clearing vegetation. The breach is not serious and does not threaten the integrity of the structure.

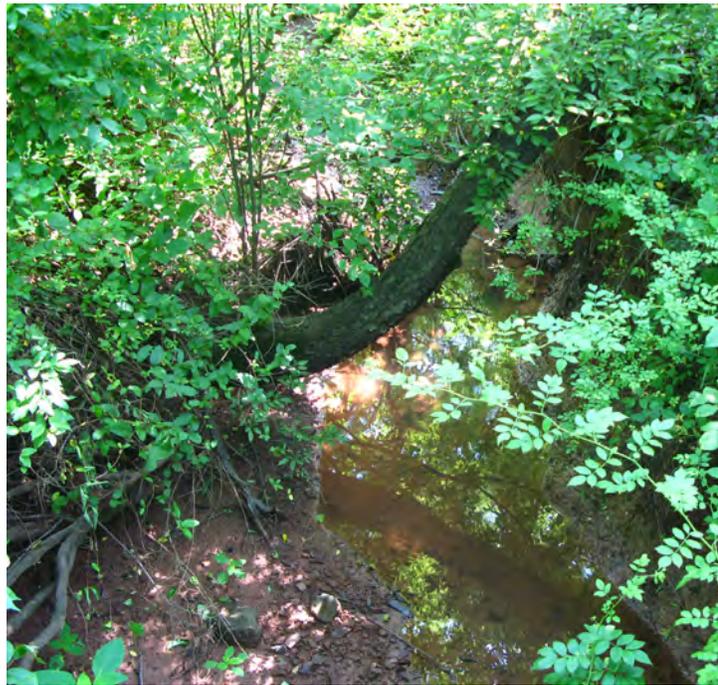
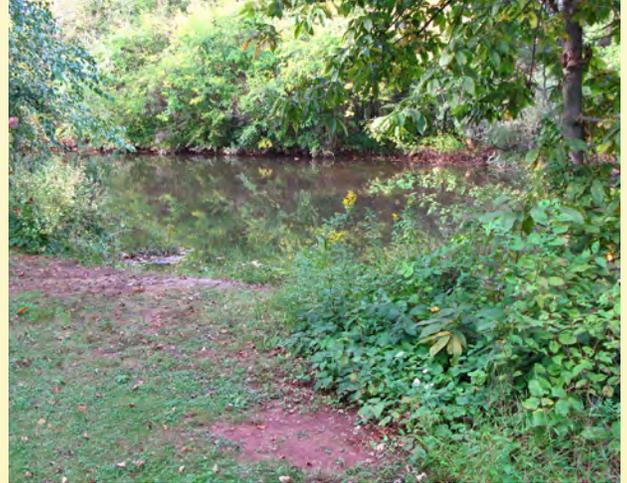
Figure 1: 100-Year Floodplain

Creek flooding has been an ongoing problem in the Park as large areas are occasionally under water or are wet, thus limiting use and access to the creek's edge. The southern edge of the creek has little riparian buffer due to past and present maintenance practices. Mowing opens views to the creek and allows access to the edge, but has contributed to erosion and establishment of invasive plant species.

A number of small tributaries originating in the southern and southwestern sections in the park terminate into Towamencin Creek as well as drainage swales with stormwater runoff from Bustard Road.

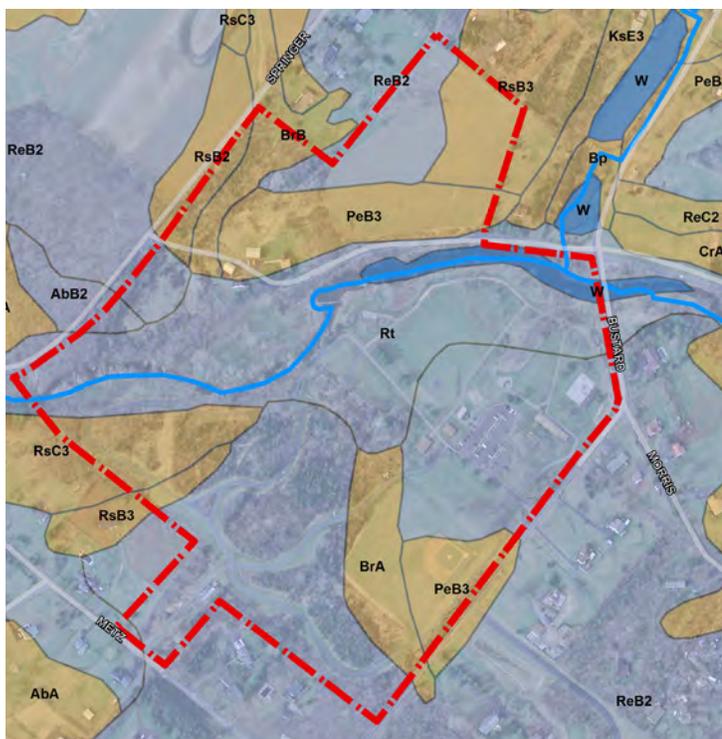
Figure 2: Park Soils

Soil locations in the park as illustrated the Park Soils map below. Hydric soils are shown in blue. Areas proposed for development are in the higher elevations of the park containing Penn silt loams. The proposed pedestrian bridge over the creek is located on Rowland silt loam and will require footings designed to be stable in these soils.

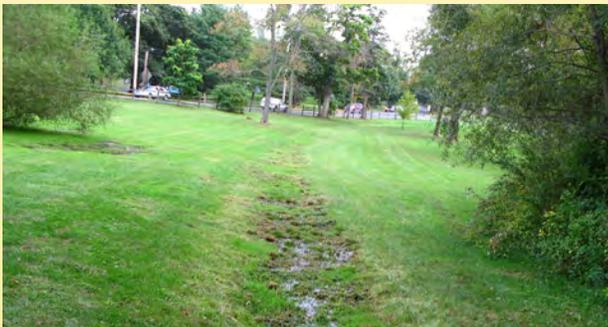
Floodplain Woodland: Areas adjacent to creek in western section of park contain a mix of Platanus, Acer species, and lack a native understory due to large amount of invasive species including Acer Platanoides, Rosa Multiflora, and Lonceria Japonica. A more in-depth survey of the riparian buffer can be found in the township stream corridor study.

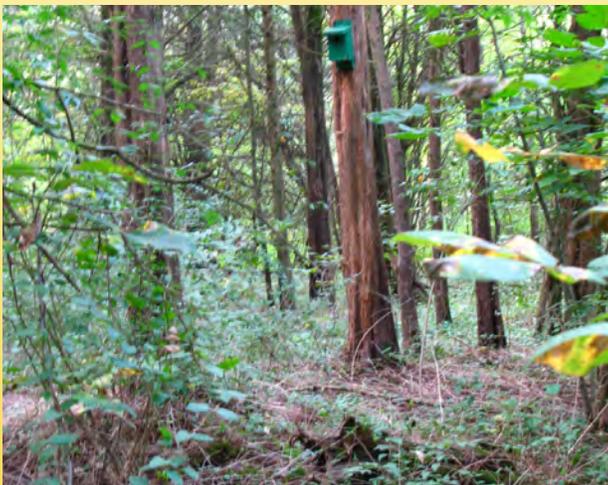
Floodplain Meadow: This area is located along southern side of Towamencin Creek and below the Arneth farmstead and contains a mix of grasses and perennials. It is a mown area.

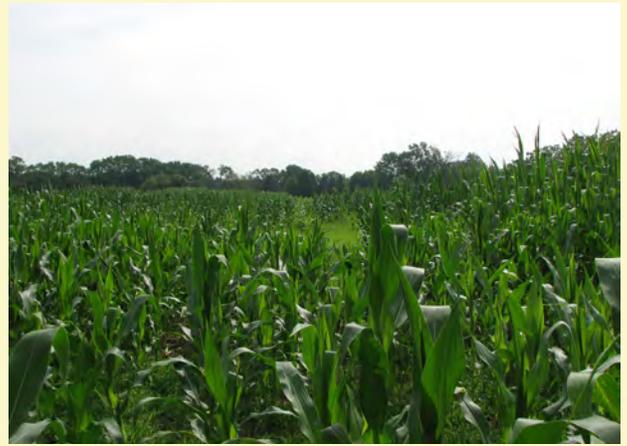
Upland Meadow: This vegetation type includes areas north of Kriebel Road and is most suitable to farming, being the least affected by flooding. A large portion of this area is currently planted with corn during the growing season. Where agriculture and mowing has not occurred, a second successional growth of multi-flora rose, crabapple and cedar have been established.

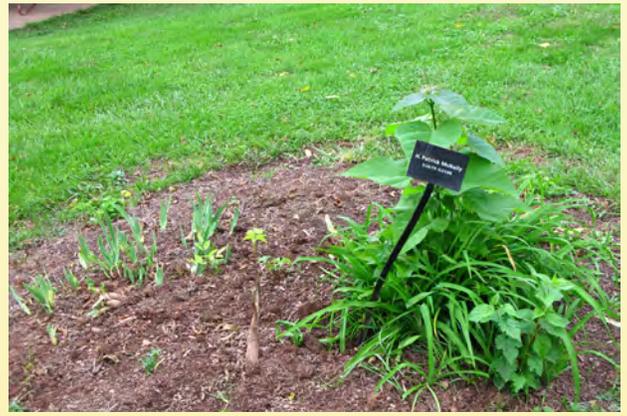
Memorial Plantings: The Park contains a significant number of memorial plantings, mostly ornamental trees. Memorial plaques must be maintained against damage from mowing and park users and flags, flowers, and other offerings have to be removed. The Township should offset the extra expenses of maintaining memorial plantings by setting up a memorial maintenance fund and specifying the types and locations of trees to be planted.
